LABORATORY REPORT

Report No.: 10100547-002-v1
Date Received: 10/15/2010
Date Reported: 11/4/2010
P.O. No.: Verbal VB

Sample Description: Implant with an abutment attached

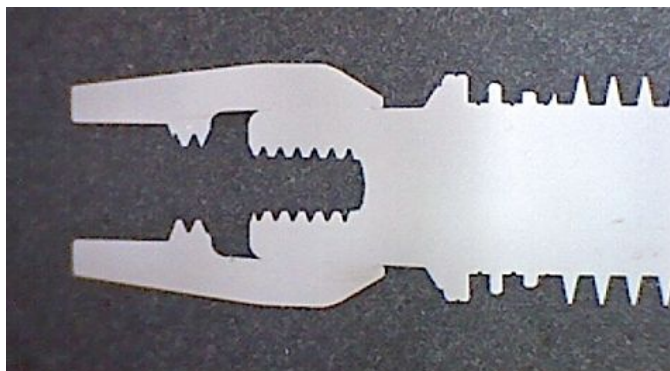
Figure 1, Cross section of the implant with the abutment inserted at 10X magnification

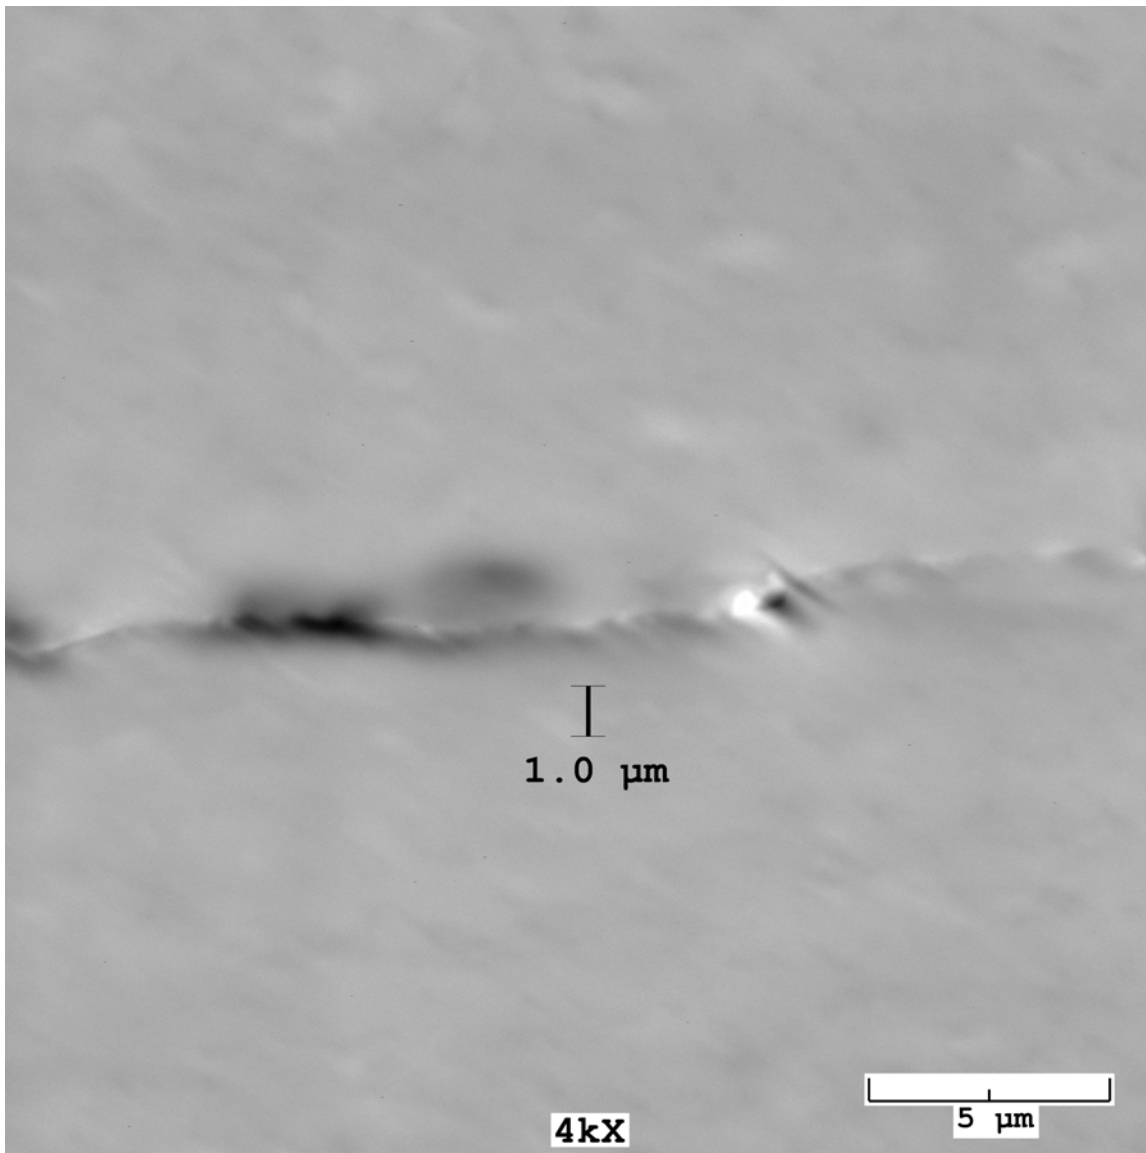
The dental implant and abutment were in intimate contact (no gap was detected) in continuous areas along the interface length.

Figure 3, A section of the Implant / abutment interface as viewed with a SEM at 4000X magnification. The dark areas are discolorations from the polishing process.
